NEW MEXICO ENVIRONMENT DEPARTMENT

Re: **Greater Kudu/ Project Antelope; CGP; SIC 1541; NPDES Compliance Evaluation Inspection;
NPDES #NMU001949; November 1, 2017**

NPDES Compliance Inspection Report

NPDES Construction General Permit Inspection Report – State of New Mexico

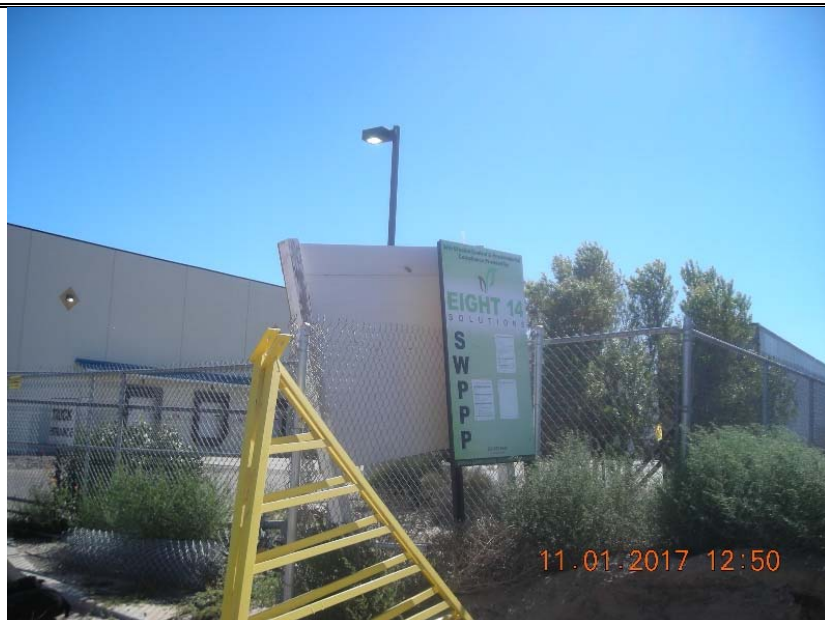
The public NOI posting was facing the inside of the site located inside the access control and was therefore not visible to the general public.

- Part 1.5 SWPPP Public posting was located inside a fence with access control and facing inwards (photo 2).

NMED/SWQB Official Photograph Log Photo # 2		
Photographer: Jennifer Foote	Date: 11-1-17	Time: 12:50 pm
City/County: Los Lunas/Valencia		State: New Mexico
Location: Project Antelope		
Subject: SWPPP NOI Posting facing away from the public, inspector is standing inside the site looking out

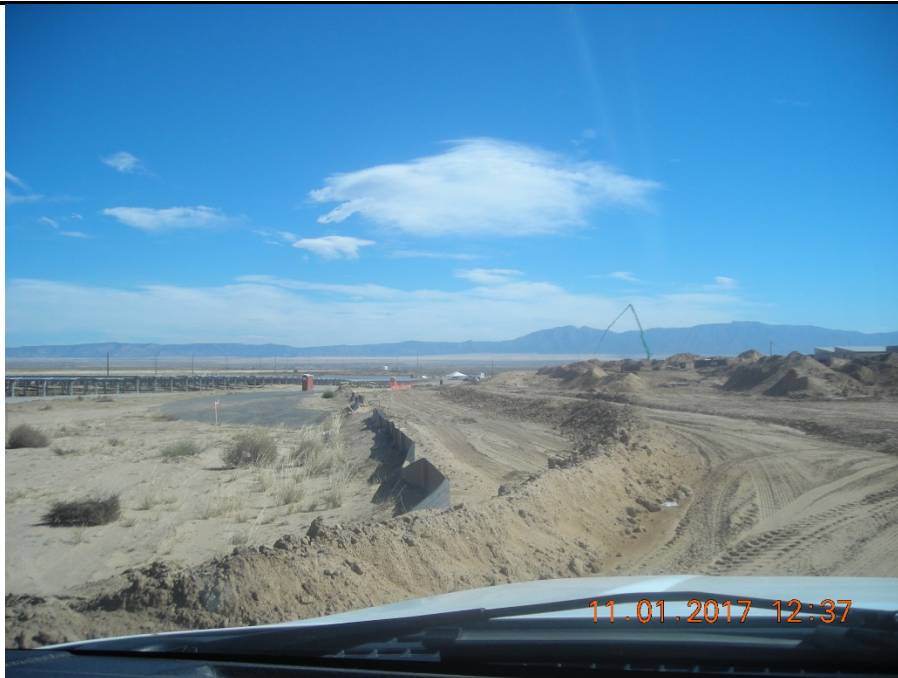
Silt fences on the north side of the site had been damaged by recent grading operations and was not yet repaired. Check dams were not included in the original design but were installed along the road on the south side after they were found to be necessary.

NMED/SWQB Official Photograph Log Photo # 7		
Photographer: Jennifer Foote	Date: 11-1-17	Time: 12:37 pm
City/County: Los Lunas/Valencia		State: New Mexico
Location: Project Antelope		
Subject: silt fence on north side of site damaged by grading

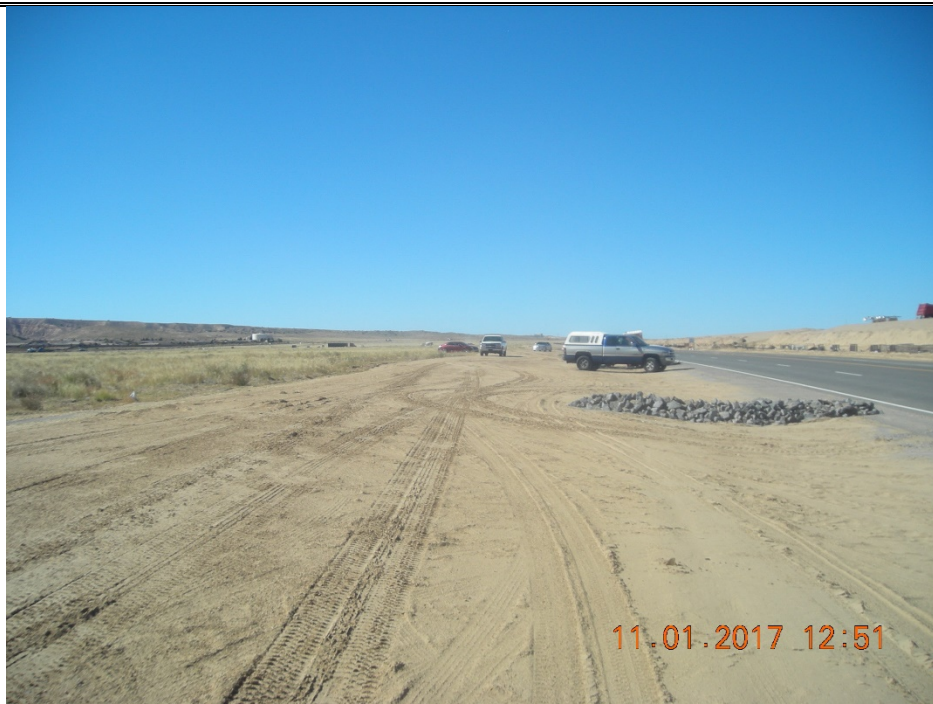
NMED/SWQB Official Photograph Log Photo # 8		
Photographer: Jennifer Foote	Date: 11-1-17	Time: 12:28 pm
City/County: Los Lunas/Valencia		State: New Mexico
Location: Project Antelope		
Subject: New check dams on south side of site
